SURFRIDER FOUNDATION, SAN FRANCISCO CHAPTER

A HISTORY OF COASTAL EROSION AT OCEAN BEACH

A historical review of coastal erosion episodes at San Francisco's Ocean Beach

4/16/2012

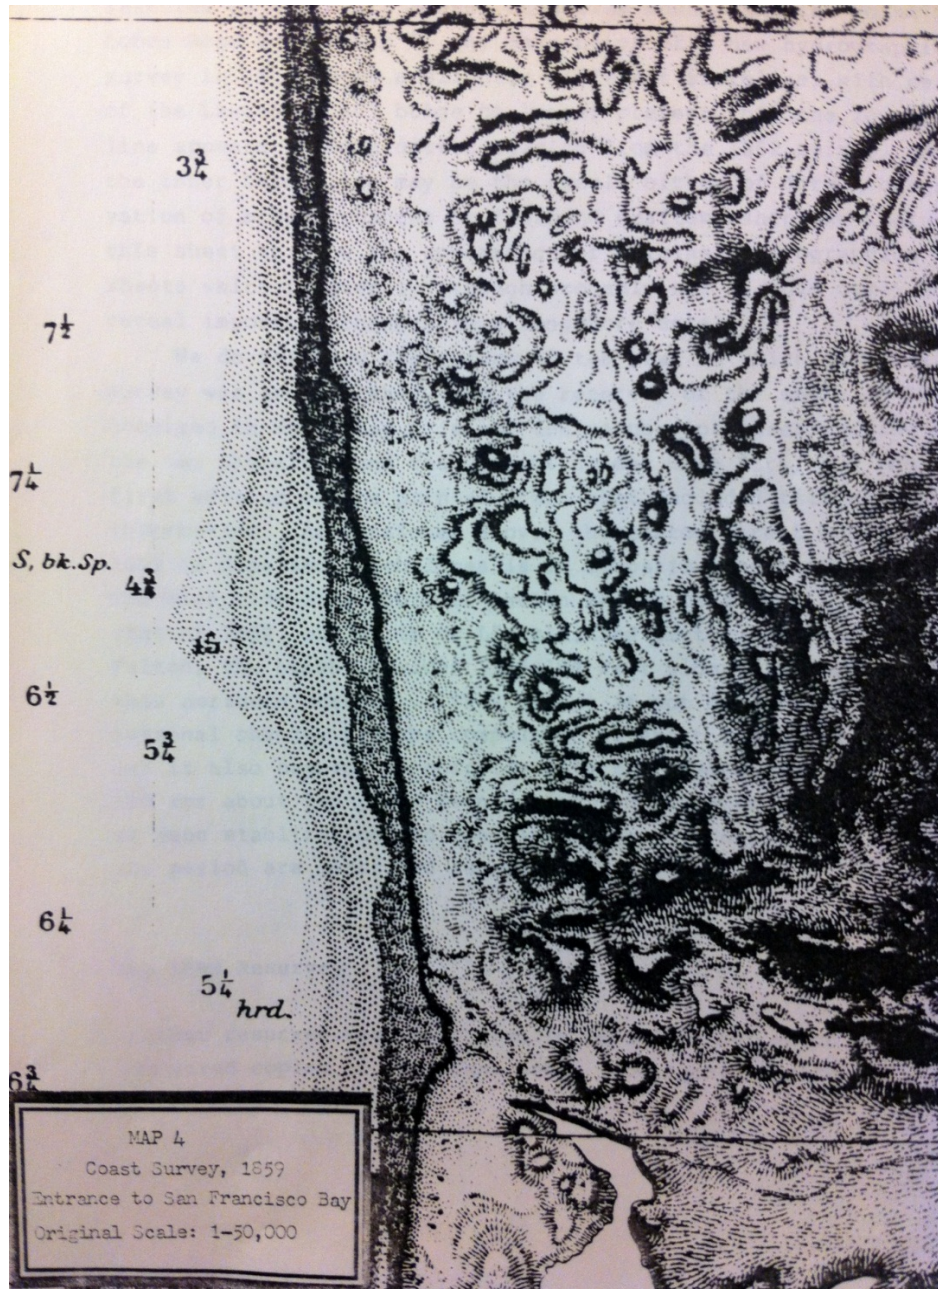
What is noteworthy about the above map from 1859 is the area just west of north Lake Merced. Apparently, this is the site where the lake, then a lagoon, emptied into the ocean. When this map was made, there was no discernible connection between the two bodies of water. However, we do see a rather extensive area of erosion on the beach just northwest of the lake.

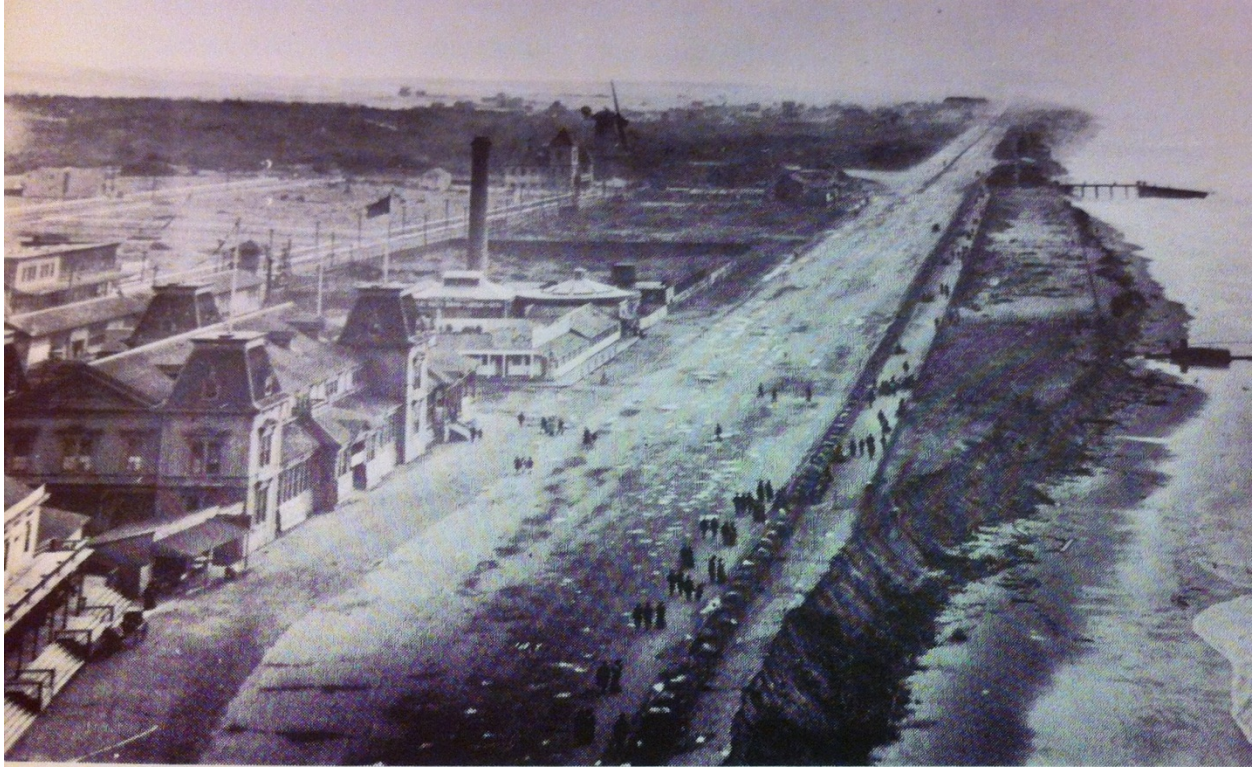
The wider the Great Highway, the more it crumbled, ca. 1907.

This photo features a powerful display of beach loss that comes from a major erosion event. Strong winter storms were the culprit. Large storm waves combined with high tides can remove massive amounts of sand from the shoreline, causing a radical drop in the elevation of a beach. (Gary Griggs, 2005)

Public visitation to Ocean Beach continued to grow as the years went on. By the early 1900's there was an effort to improve and widen the Great Highway to accommodate the crowds. This is where we see some of the first photographic evidence of coastal erosion damage. In the 1907 photograph shown below, winter storms chewed away part of the recently widened road.

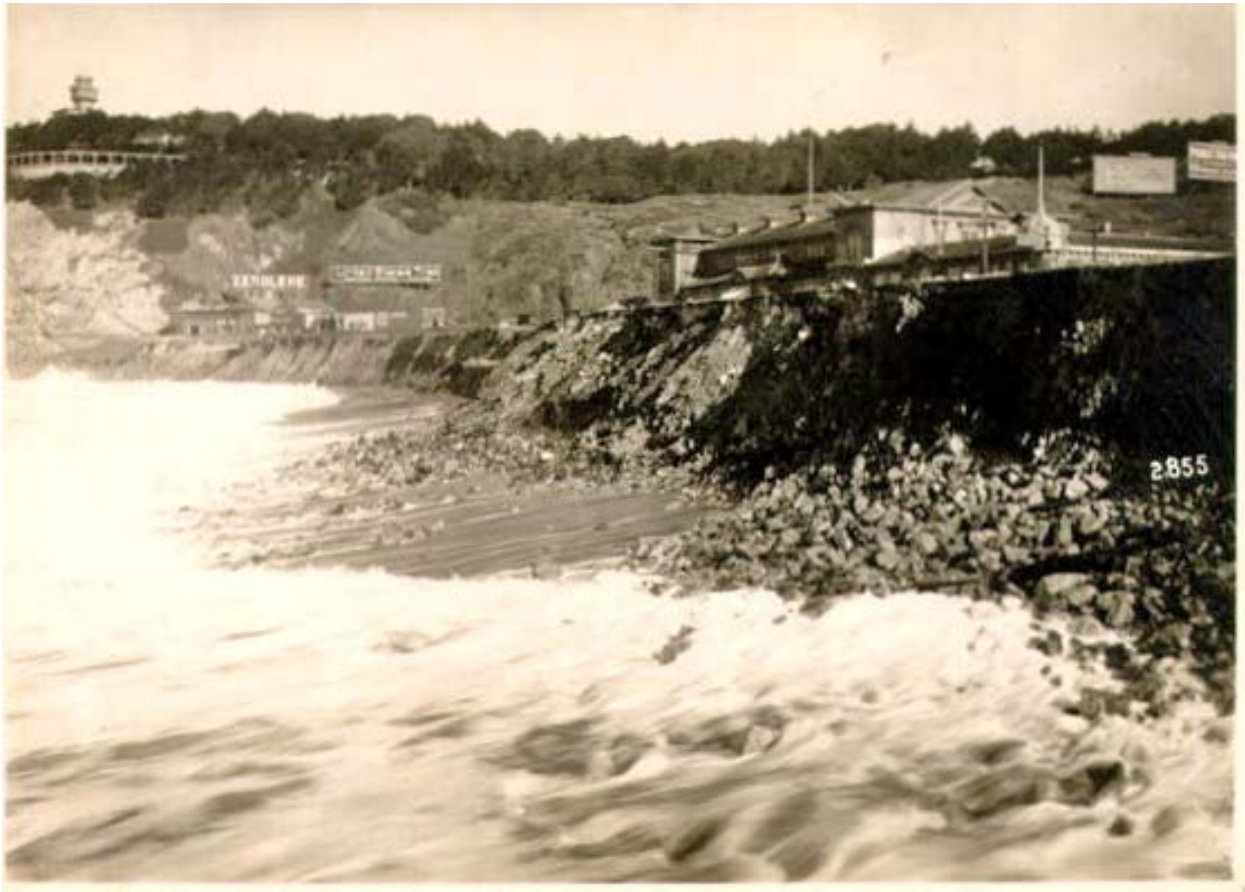
North Ocean Beach 1914: Material from Mile Rock was used as erosion defense.

During the winter of 1914, a major storm came barreling down from Canada causing widespread coastal erosion up and down the entire west coast. (Freeman, 2011) Yet more sand was stripped from the beach at the north end. In the above photo we see evidence of the first attempt to protect the Great Highway with hard structure. Boulders from Mile Rock were dumped onto the beach. This effort was also unsuccessful as the stones were easily washed away. (Olmsted, 1979)

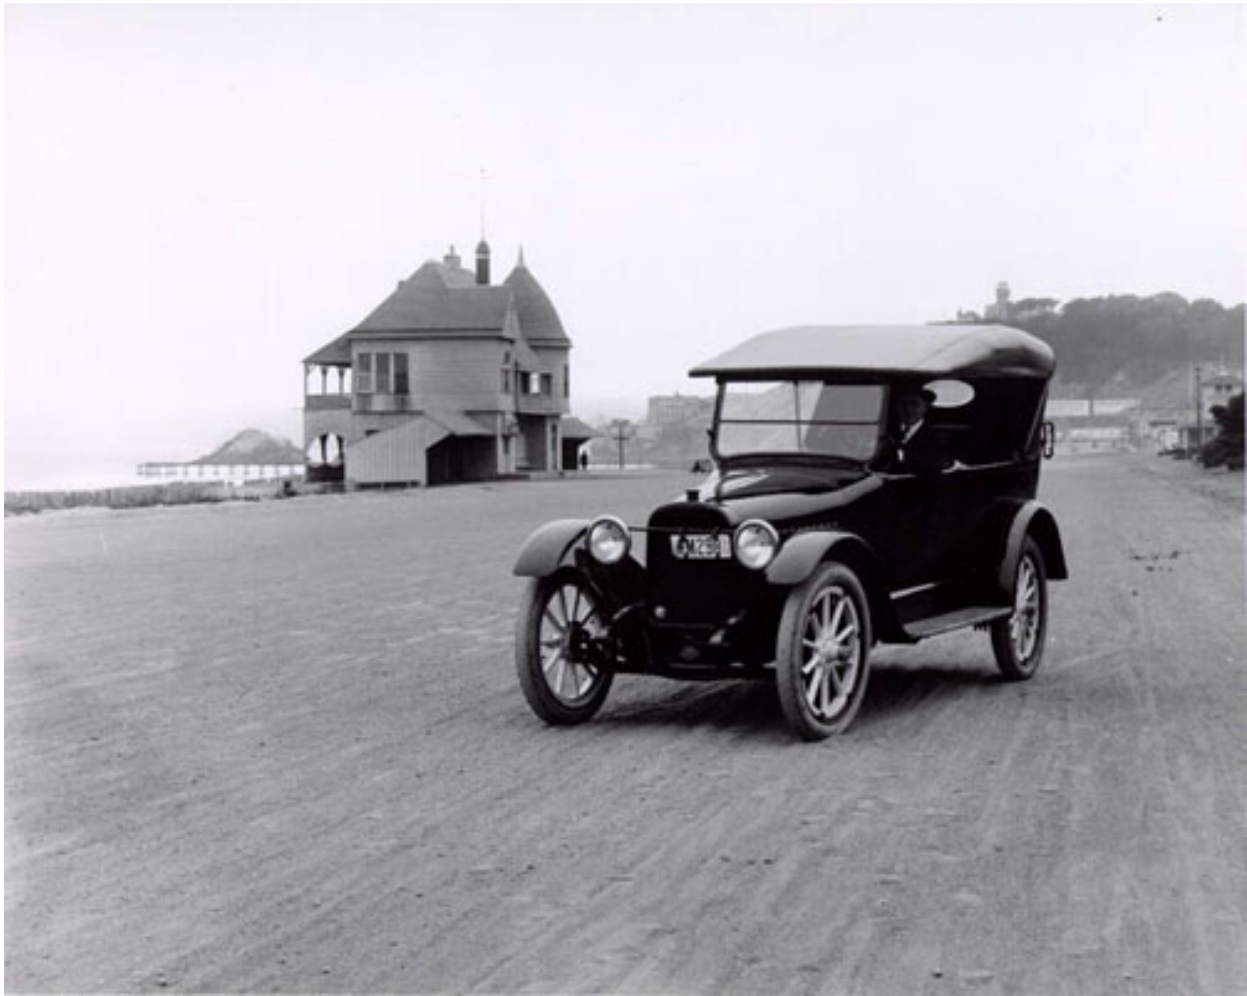
Above: The original Beach Chalet was located right on the beach. (San Francisco Public Library Historical Photo Collection)

By 1906, park records show the building's foundation was in need of repairs probably due to wave attack. (Freeman, 2011) Three years later, in 1909, a 300 foot long seawall was built to protect the structure. It consisted of concrete pilings sunk 15 feet into the sand. Completed in 1911, it was the first seawall to be built at Ocean Beach. However, it was virtually wiped out by the storm of 1914. The photo below shows the aftermath of that storm. Notice that there is yet more road failure due to

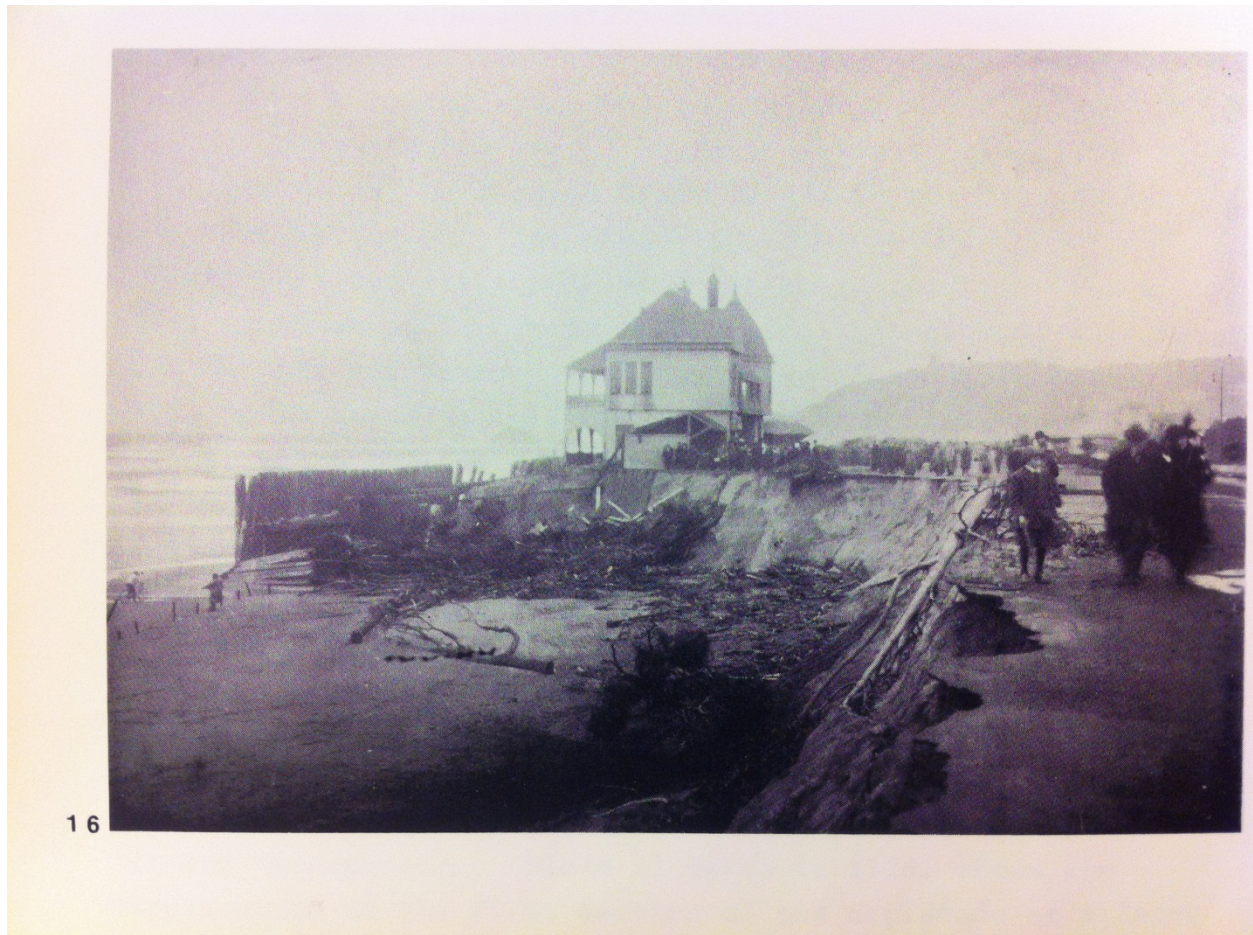
severe beach loss.

Miraculously, the Beach Chalet survived this storm. A few years later the building was wisely relocated well inland. (Freeman, 2011) This appears to be the first instance of the use of landward relocation as erosion response at Ocean Beach.

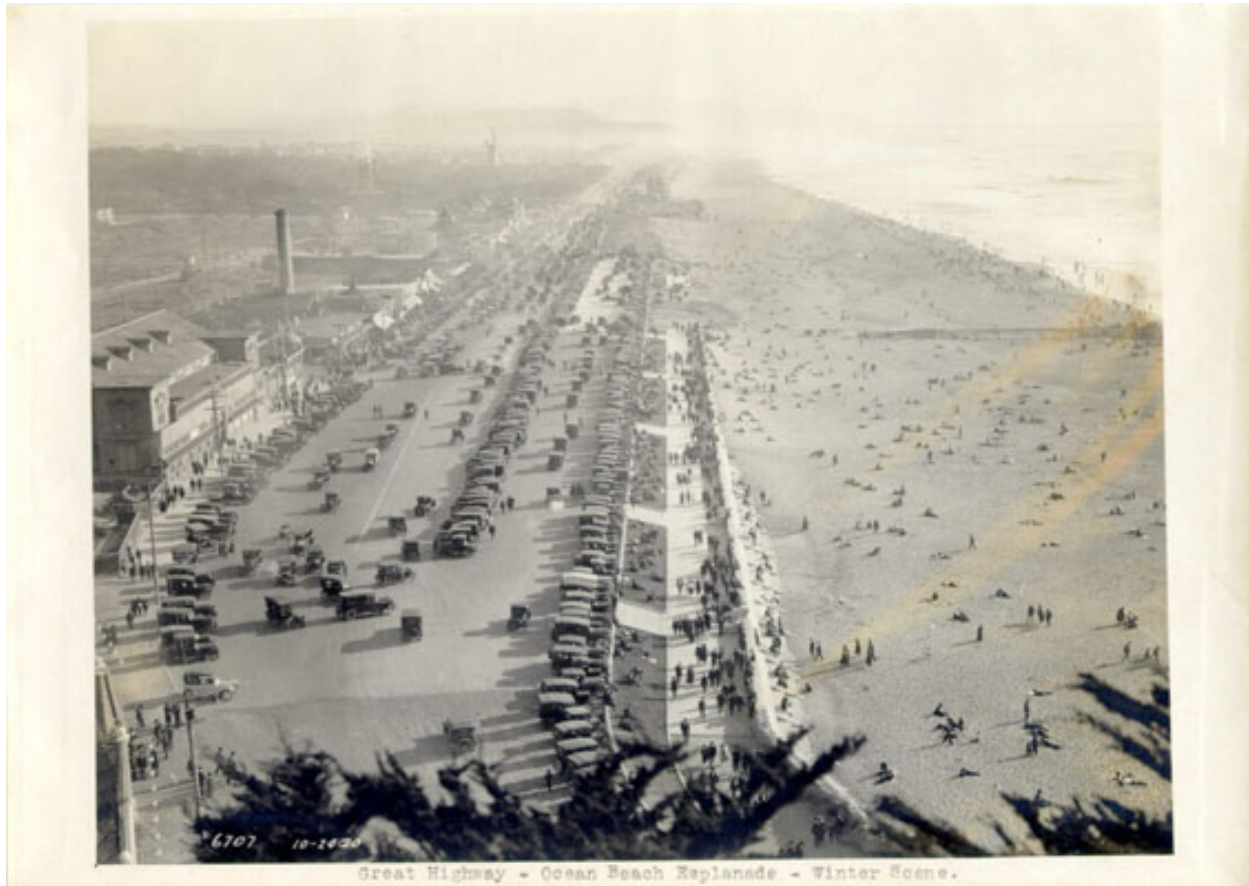
O'Shaughnessy's Ocean Beach Esplanade and seawall was a success. Completed in 1928, the seawall project was accompanied by a fully paved version of the Great Highway. The seawall itself had an innovative design. It sported concrete stairs at its base which served to diffuse wave energy like a revetment. The bulk of the wall had a concave shape to deflect inbound surf back towards the sea. Overall, compared to the structure that protected the Beach Chalet, O'Shaughnessy's seawall was built with more attention to anchoring and reinforcement issues. To this day it survives, virtually damage free. (Olmsted, 1979) The above photo is from 1920 when the seawall was half complete. Notice the difference in the width of the beach since the storm of 1914. An enormous amount of sand had returned to the area after six years.

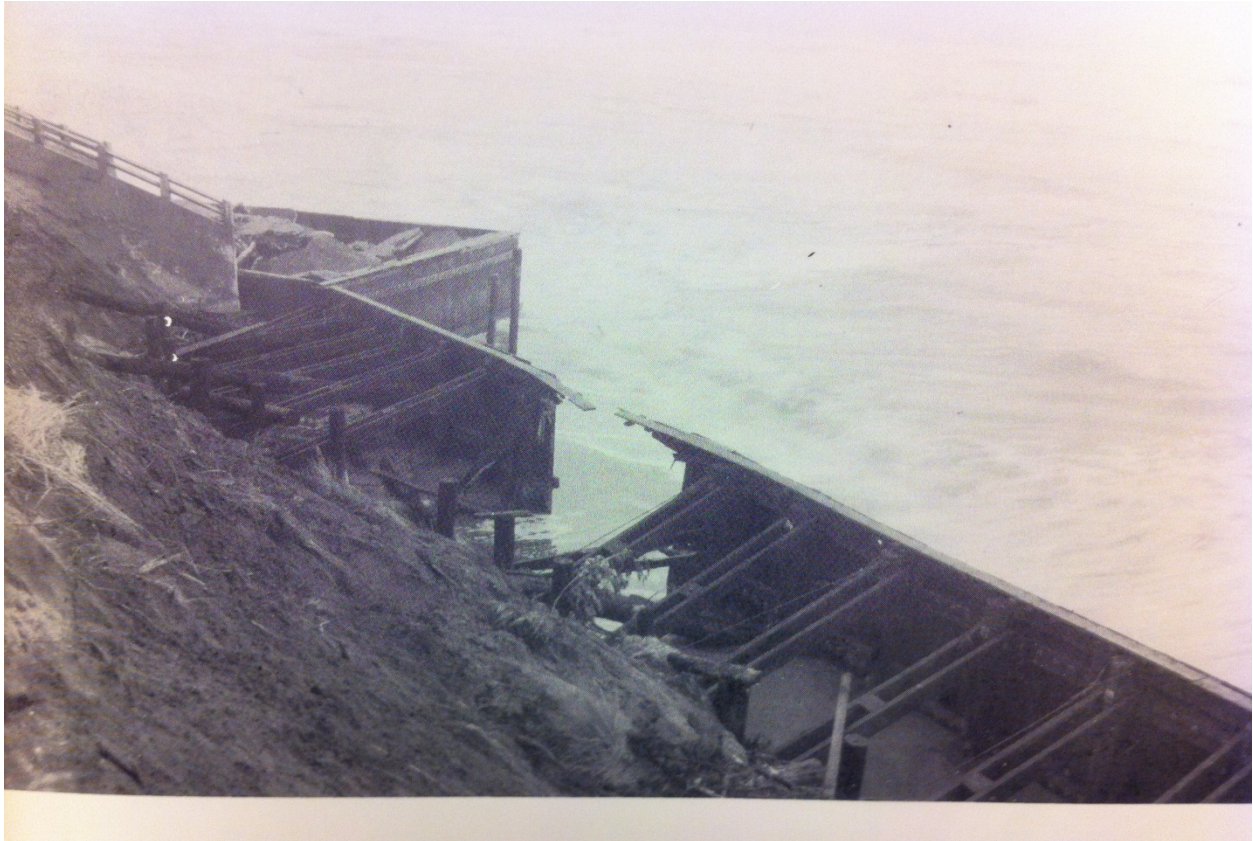
The original seawall at Taraval with storm damage (Olmsted, 1979)

The 1930s had a number of winters with powerful storms that brought problems to the newly paved Great Highway. With the north end now apparently in an accretion cycle, trouble spots began to appear at the south end. The Taraval Street area was hit particularly hard during this decade. Waves damaged a new pedestrian underpass and threatened to overtake the road. A seawall was constructed, but had to be repaired twice due to storm damage.

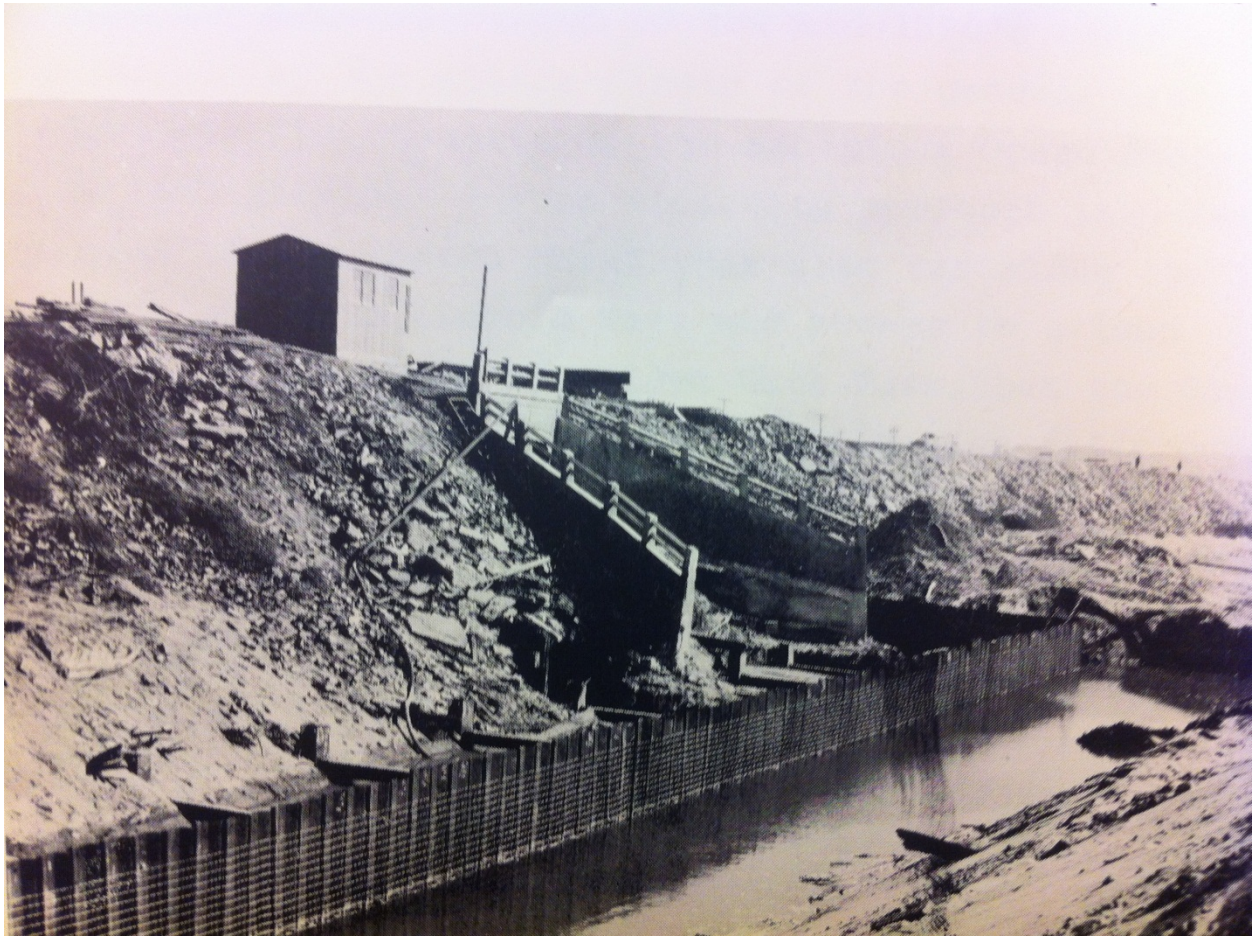
Construction of the Taraval Seawall (Olmsted, 1979). This structure can still be found today partially buried under the sand. Notice the use of construction debris as fill to stabilize the dunes.

It wasn't until 1941 when a third seawall was constructed that the Taraval area was stabilized. The new structure consisted of a three sided sheet pile wall anchored deep into the sand. The top was fitted with a concrete cap. (Kingerly, 1998) This seawall, while fairly successful at protecting the road and underpass, did need reinforcement. Concrete debris and construction fill were placed on the beach in front of and behind the structure. (Olmsted, 1979) Unfortunately, the practice of dumping concrete debris on Ocean Beach became an accepted tool in combating erosion.

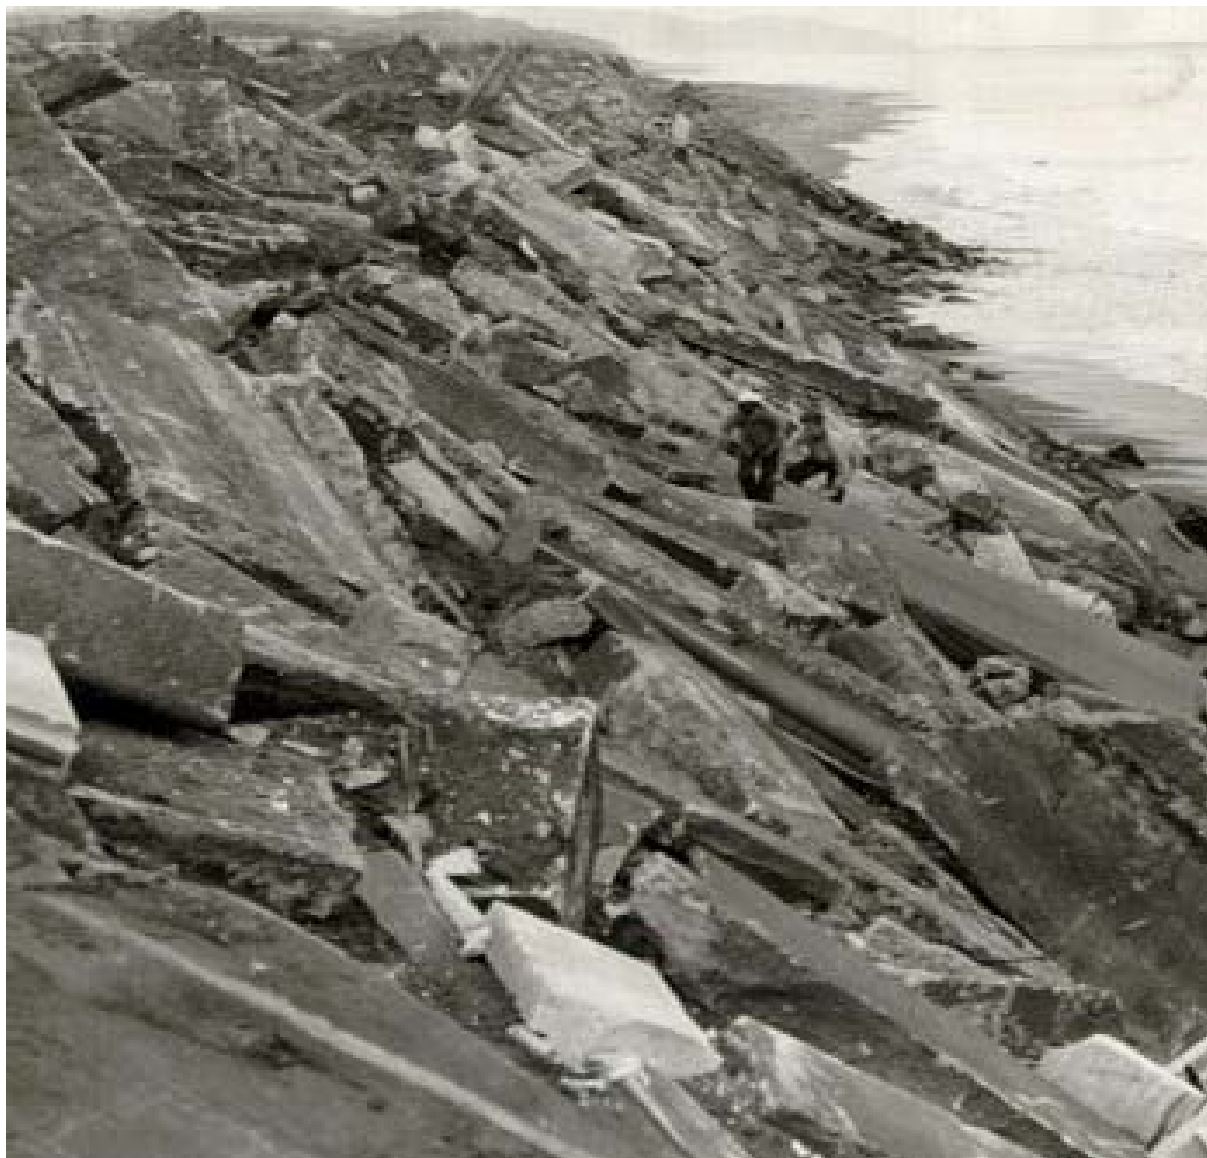
Rivera Street 1944 (San Francisco Public Library Historical Photo Collection)

In the 1940s, The Great Highway was threatened once again. This time the problem was at Rivera Street. Instead of constructing another seawall, a makeshift revetment made of tombstones was dumped on the beach. The gravestones came from the Laurel Hill cemetery after it had recently closed due to pressure from developers. (San Francisco Public Library Historical Photo Collection) This picture looks eerily similar to the present-day shoreline at Sloat.

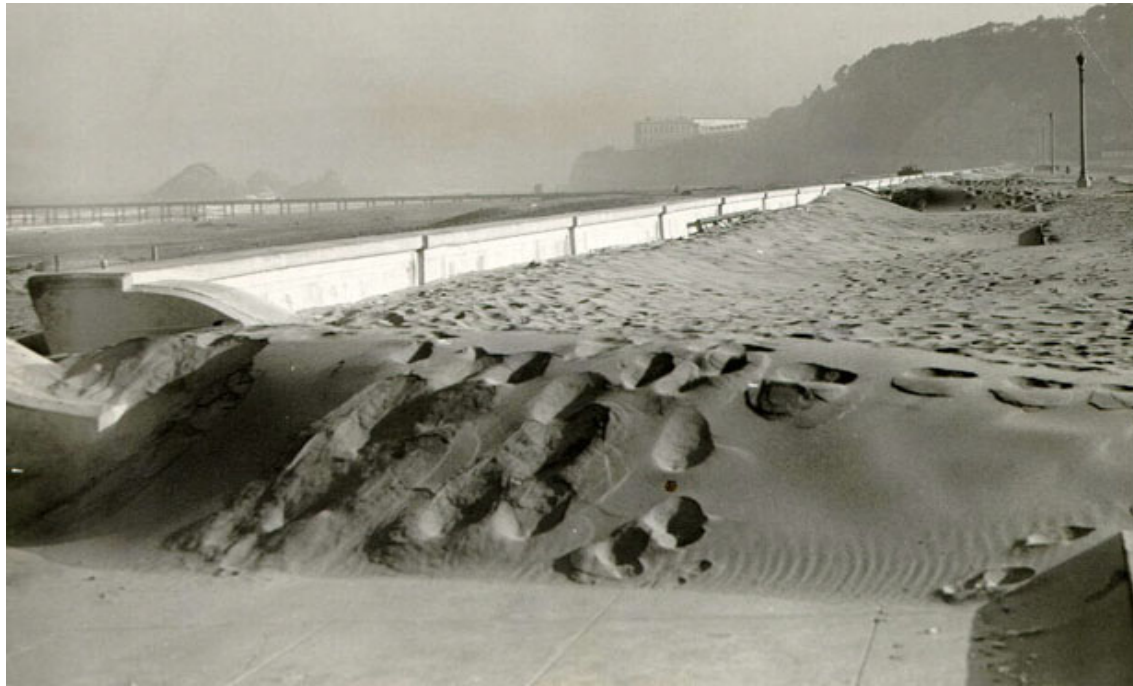
The Ocean Beach Esplanade 1942 (San Francisco Public Library Historical Photo Collection)

Meanwhile at the north end of the beach, there was plenty of sand between the Great Highway and the water. In fact, the size of north Ocean Beach in the 1940s looks quite close to what we have today.

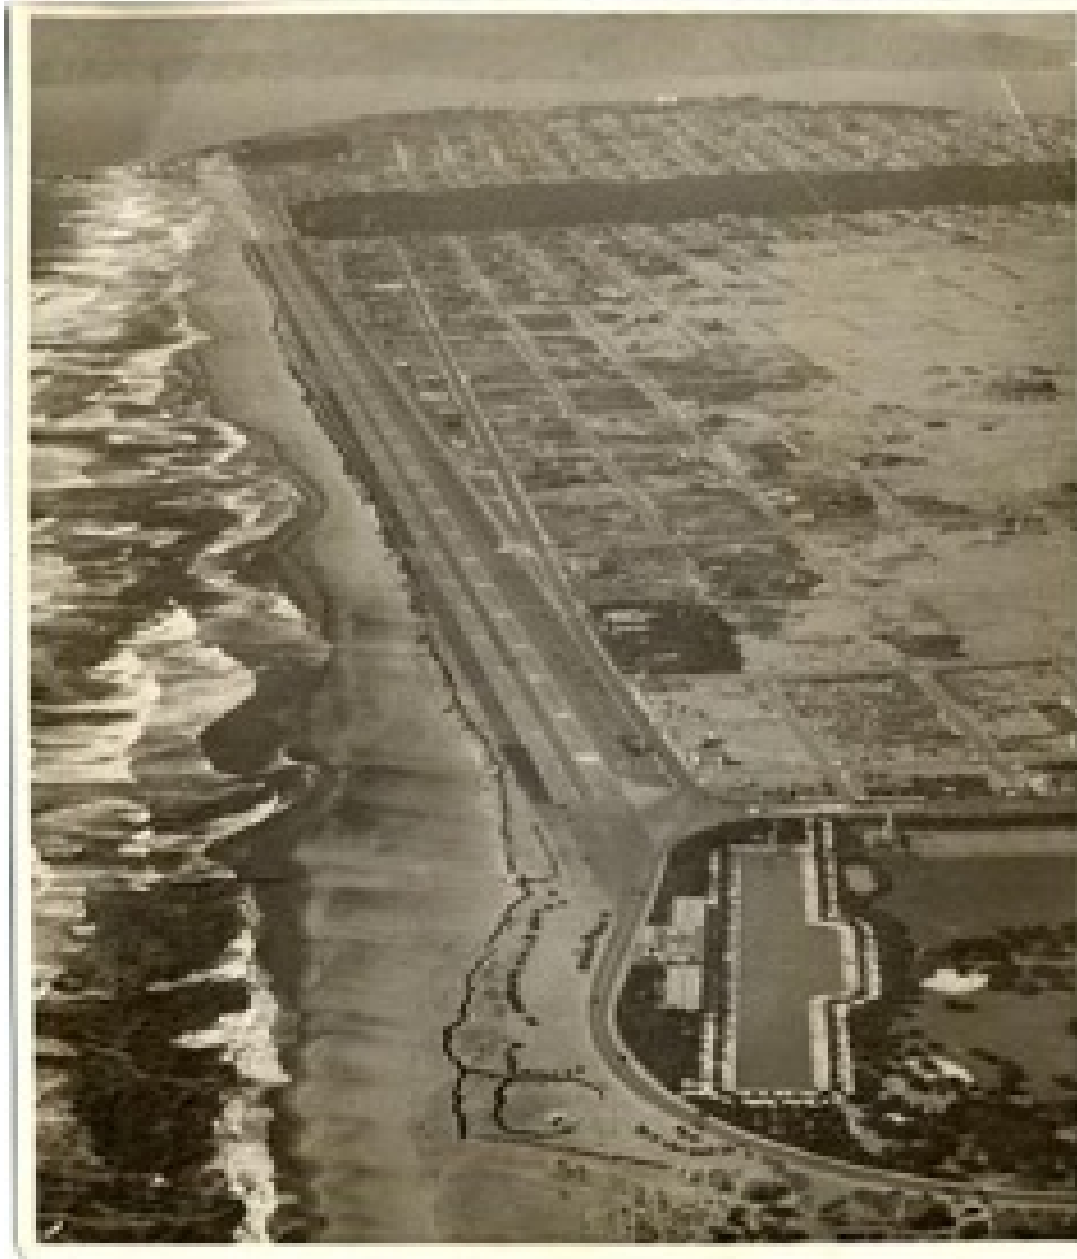
Sloat Area Beach 1952 – plenty of sandy shoreline once existed in the Sloat area. (San Francisco Public Library Historical Photo Collection)
